**Flood Control Project Maintenance
Levee Inspections**

Maintenance Issue Types Only, Levee Inspection Report By Mile - Fall 2016

City of Sacramento

Waterway	Bank	Unit Miles	Inspection Start/End	Inspector
Unit No. 01 Sacramento River	Left	3.67	09/15/2016 09/15/2016	Oleg Yakimov

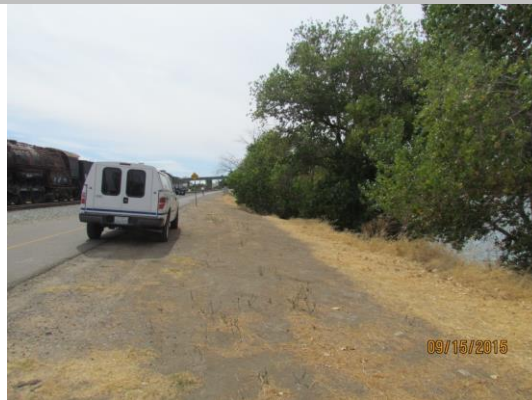
Photo 1 of 2 : FA_2016_NA0005_251_13_20160913_00010.jpg

LM Start	1.16	Rating **	M	Issue No.	13
LM End	1.69	Issue Type +	Ma	Location *	WS
Category	Earthen Levee			GPS Latitude/Longitude	
				Start	End
Item	Trim / Thin Trees			38.574780 °	38.568757 °
				-121.510191 °	-121.515930 °
DWR ID	DWR_NA0005_01_f_2012_13				
Comment Code					
T2 : Thin trees to allow visibility of the ground and room to flood fight.					
Inspector Comment

Monitor trees and woody vegetation along the rivers edge looking downstream. Fall 2015.

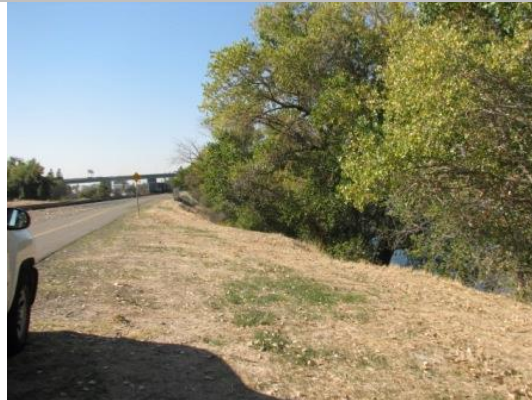
Photo 2 of 2 : FA_2016_NA0005_251_13_20160913_00011.jpg

Monitor the trees and woody vegetation along the rivers edge. Fall 2013

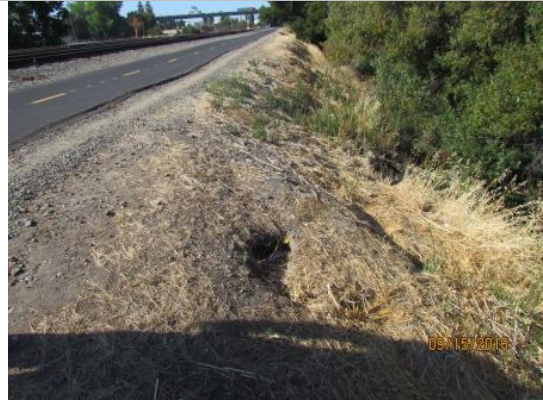
Photo 1 of 1 : FA_2016_NA0005_251_75_20160915_00115.jpg

LM Start	1.25	Rating **	M	Issue No.	75
LM End	1.25	Issue Type +	Ma	Location *	WS
Category	Earthen Levee			GPS Latitude/Longitude	
				Start	End
Item	Animal Control			38.573704 °	38.573704 °
				-121.511219 °	-121.511219 °
DWR ID	DWR_NA0005_01_f_2016_75				
Comment Code					
A3 : No rodents visible, but rodent burrows visible; need to backfill and compact or grout burrows.					
Inspector Comment

View of rodent holes on waterward side of the levee. Fall 2016 inspection.

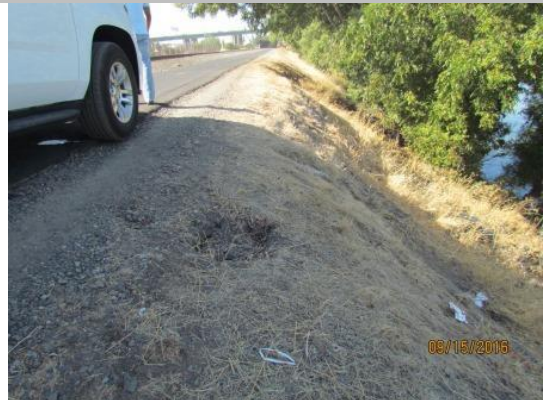
Photo 1 of 1 : FA_2016_NA0005_251_76_20160915_00116.jpg

LM Start	1.29	Rating **	M	Issue No.	76
LM End	1.29	Issue Type +	Ma	Location *	WS
Category	Earthen Levee			GPS Latitude/Longitude	
				Start	End
Item	Animal Control			38.573240 °	38.573240 °
				-121.511707 °	-121.511707 °
DWR ID	DWR_NA0005_01_f_2016_76				
Comment Code					
A3 : No rodents visible, but rodent burrows visible; need to backfill and compact or grout burrows.					
Inspector Comment

Rodent hole backfilled with natural soil on waterward side of the levee. Fall 2016 inspection.

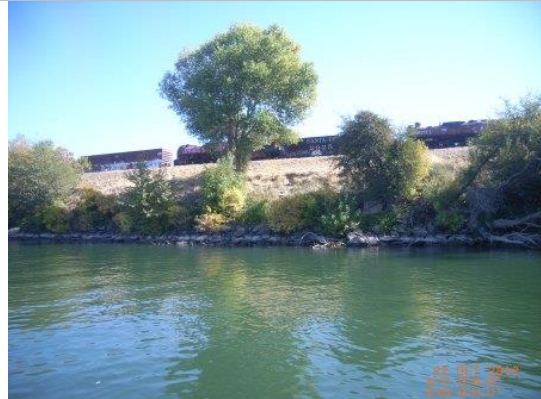
Photo 1 of 2 : FA_2016_NA0005_251_1_20160913_00001.jpg

2008 - Oversized levee, should be repaired under maintenance. 2009 - Shallow slumps at the mid bank. 2010 - Some minor erosion at the toe, likely from wave wash. Some new shallow slumps. 2011 - One new tree has fallen. 2013 - Erosion continues on the slope surface, site extended upstream. 2015: No observed changes. [2015 Site ID: SAC_58-5_L]

USACE 2013 Photo #1

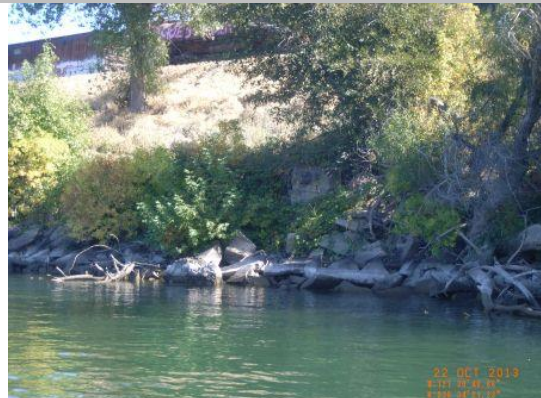
Photo 2 of 2 : FA_2016_NA0005_251_1_20160913_00002.jpg

USACE 2013 Photo #2

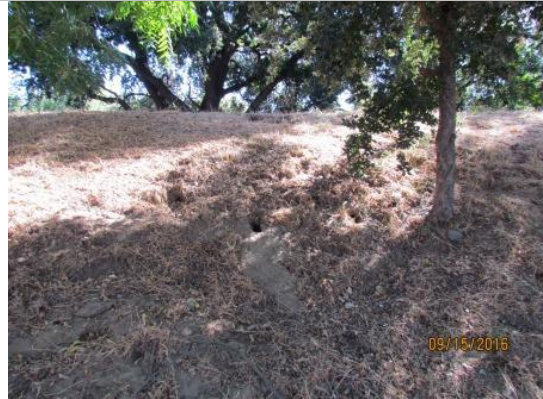
Photo 1 of 1 : FA_2016_NA0005_251_77_20160915_00118.jpg

LM Start	2.30	Rating **	M	Issue No.	77
LM End	2.30	Issue Type +	Ma	Location *	WS
Category	Earthen Levee			GPS Latitude/Longitude	
				Start	End
Item	Animal Control			38.559889 °	38.559889 °
				-121.515341 °	-121.515341 °
DWR ID	DWR_NA0005_01_f_2016_77				
Comment Code					
A1 : Exterminate rodents and backfill and compact or grout burrows.					
Inspector Comment

More squirrel holes found on waterward slope. Fall 2016.

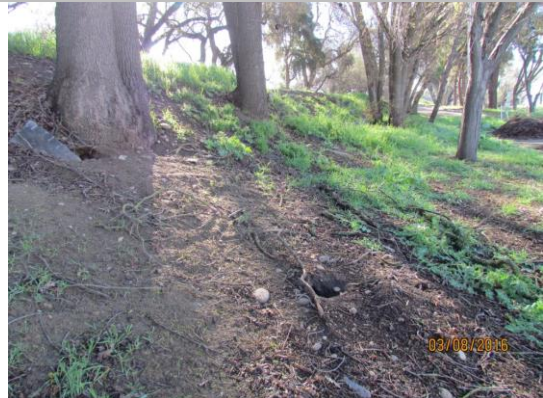
Photo 1 of 1 : FA_2016_NA0005_251_82_20160913_00014.jpg

LM Start	2.31	Rating **	M	Issue No.	82
LM End	2.31	Issue Type +	Ma	Location *	WS
Category	Earthen Levee			GPS Latitude/Longitude	
				Start	End
Item	Animal Control			38.559767°	38.559767°
				-121.515264°	-121.515264°
DWR ID	DWR_NA0005_01_s_2016_82				
Comment Code					
A3 : No rodents visible, but rodent burrows visible; need to backfill and compact or grout burrows.					
Inspector Comment

View of the rodent holes on the waterward side of the levee looking downstream. Spring 2016.

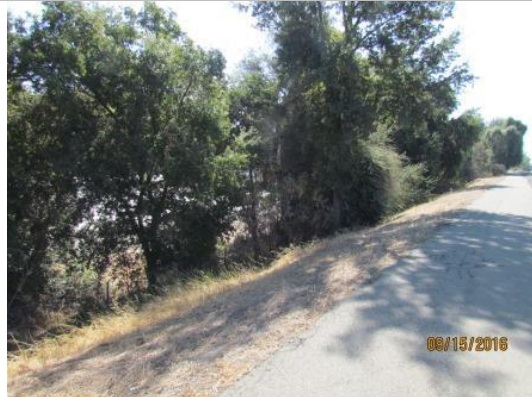
Photo 1 of 1 : FA_2016_NA0005_251_84_20160915_00120.jpg

LM Start	2.52	Rating **	M	Issue No.	84
LM End	2.92	Issue Type +	Ma	Location *	LS
Category	Earthen Levee			GPS Latitude/Longitude	
				Start	End
Item	Vegetation			38.556964 °	38.551504 °
				-121.513926 °	-121.511746 °
DWR ID	DWR_NA0005_01_s_2016_84				
Comment Code					
V2 : Remove the wild growth other than native grasses from the levee slopes.					
Inspector Comment

View of landside slope. Tree trimming and vegetation removal required. Fall 2016.

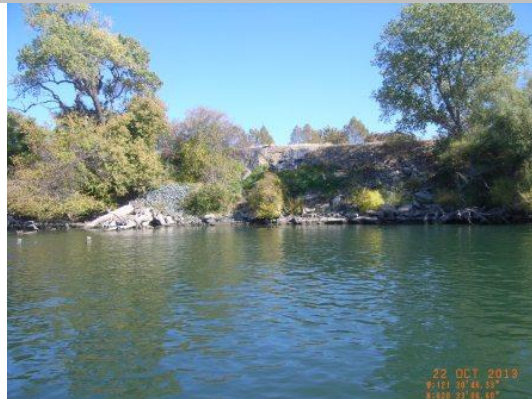
Photo 1 of 1 : FA_2016_NA0005_251_2_20160913_00003.jpg

LM Start	2.85	Rating **	M	Issue No.	2
LM End	2.90	Issue Type +	Ma	Location *	WS
Category	Supplemental			GPS Latitude/Longitude	
				Start	End
Item	2015 USACE Erosion Survey, DRAFT			38.552268 °	38.551578 °
				-121.512590 °	-121.512336 °
DWR ID	DWR_NA0005_01_s_2016_2				
Comment Code					
Inspector Comment					
1997 - Erosion at pump station, concrete debris and plastic showing. 2000 - Separation scour of bank due to poor transition. 2004 - New large tree pop out; city dumped fill dirt/rock into hole. 2006 - Minor new erosion at top of bank. 2010 - Some new rock placed in tree pop-out. 2011 - A large tree has fallen and flood fighting was performed by the city on the upper levee slope. 2012 - Small rock placed in hole from tree popout. 2015: No observed changes. [2015 Site ID: SAC_56-6_L]

USACE 2013 Photo #1

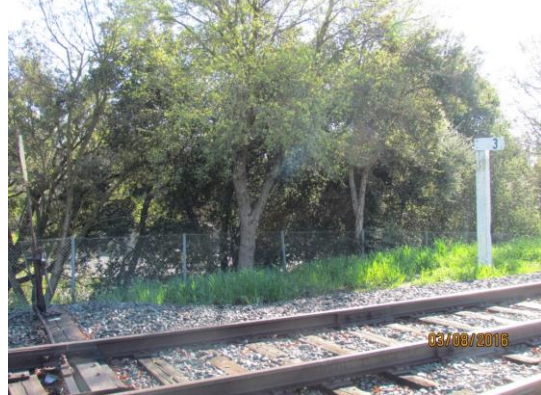
Photo 1 of 2 : FA_2016_NA0005_251_85_20160913_00015.jpg

LM Start	3.35	Rating **	M	Issue No.	85
LM End	3.35	Issue Type +	Ma	Location *	LS
Category	Earthen Levee			GPS Latitude/Longitude	
				Start	End
Item	Trim / Thin Trees			38.545403°	38.545403°
				-121.509830°	-121.509830°
DWR ID	DWR_NA0005_01_s_2016_85				
Comment Code					
T3 : Trim and thin trees to allow visibility of the ground and room to flood fight.					
Inspector Comment

View of the trees on the landward side of the levee. Spring 2016.

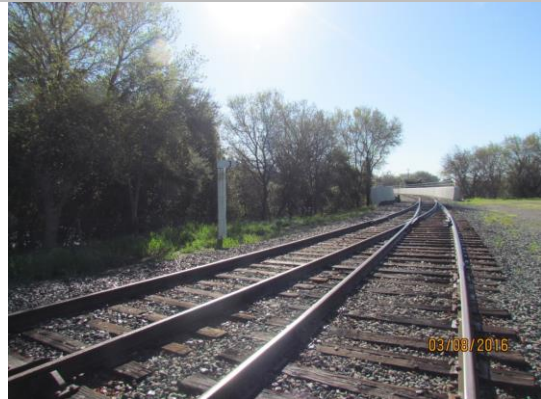
Photo 2 of 2 : FA_2016_NA0005_251_85_20160913_00016.jpg

Perspective view of the trees on the landward side of the levee looking downstream. Spring 2016.
